**IN SITU DEACIDIFICATION OF VERNACULAR WALLPAPER**

**Submitted in partial fulfillment of the requirement for the degree  
Master of Science in Historic Preservation**

**Graduate School of Architecture, Planning and Preservation  
Columbia University**

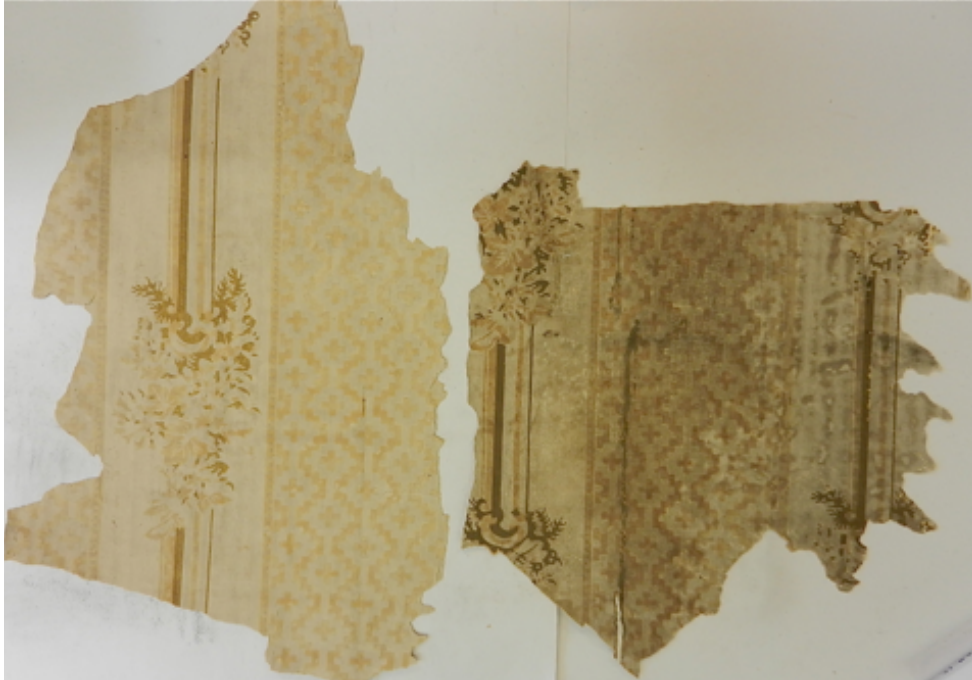
*Figure 4-1: Laboratory samples exhibited different amounts of soiling*

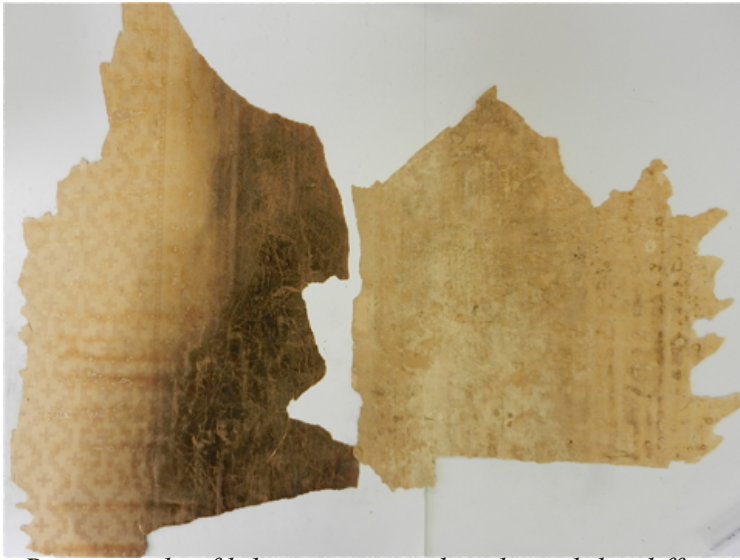
*Figure 4-2: Reverse side of laboratory samples also exhibit differing conditions*

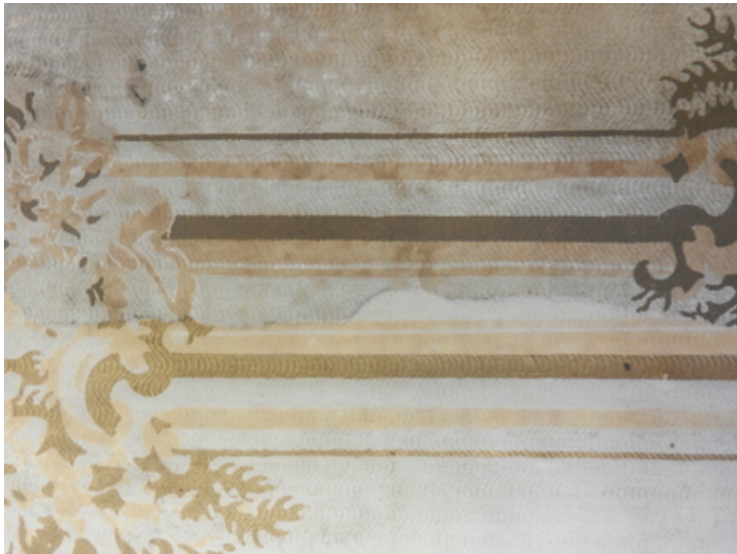
*Figure 4-3: The pattern appears different under different soiling conditions*

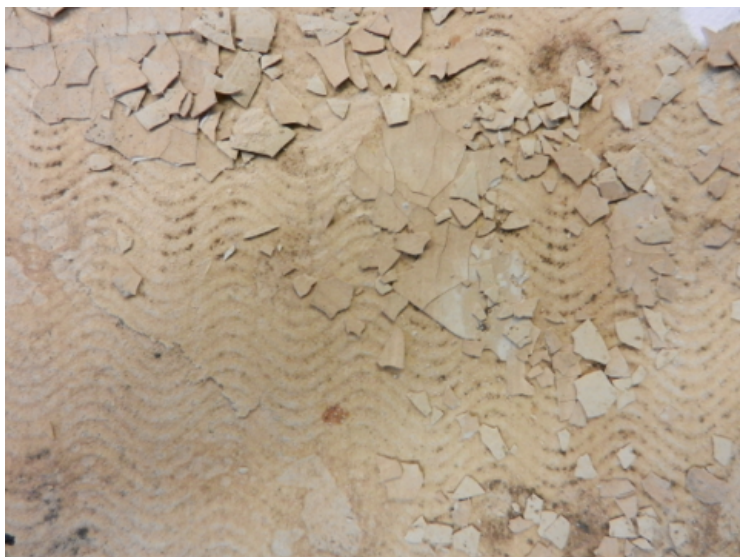
*Figure 4-4: Paint was found on the reverse side of some areas of the samples*

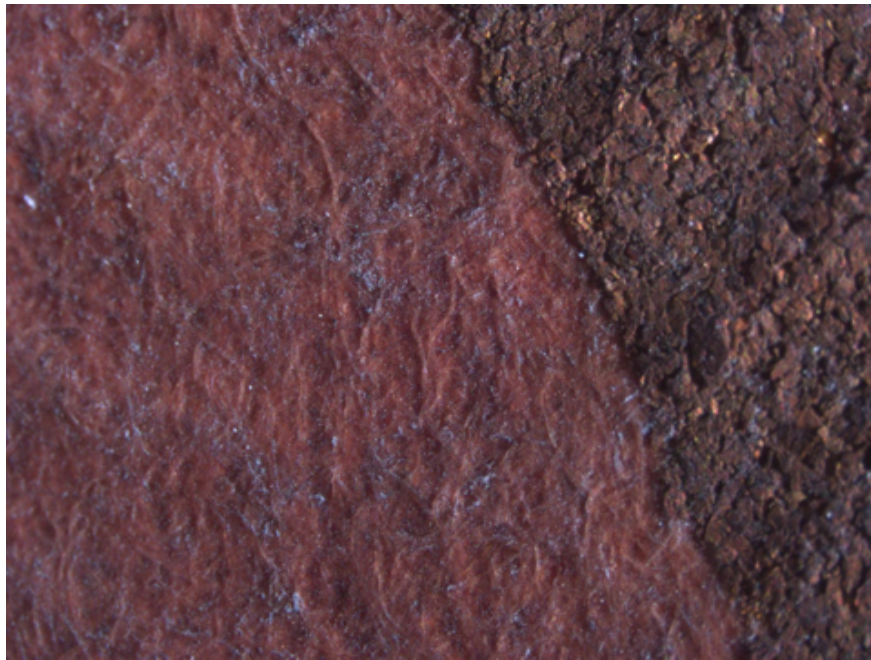
*Figure 4-11: White haze developed after application of Bookkeeper (2.5x)*

Surface cleaning was also investigated because some of the samples appeared lighter in color after being treated than they had before. 2.5x stereo zoom microscopic analysis showed that Bookkeeper left behind a white residue that appeared immediately after drying. Most of the white deposits created a veining pattern within microscopic cracks in the paint; however, a small amount was also deposited on the surface.

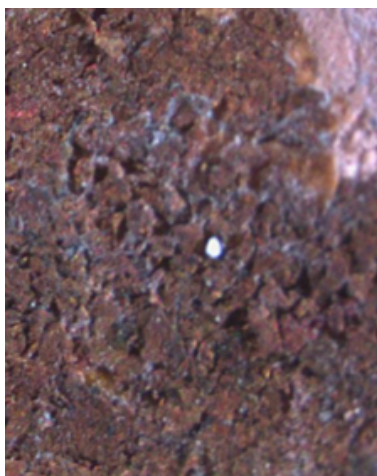
Figure 4-12: White deposit on the surface after application of Bookkeeper (2.5x)

A Staedtler® Mars® Dry Cleaning Pad was used after Bookkeeper had dried to remove deposits that were left on the surface.

The table shows that discoloration due to the application of Bookkeeper was significant enough to be perceived by the human eye. It caused the paper to become lighter, greener, and bluer in appearance. Cleaning the sample after it was treated began to counteract those changes, making it darker, redder, and yellower, however, not enough to be perceived. Whether a treated wallpaper sample should be cleaned of deacidification deposits *in situ* probably needs to be evaluated on a case-by-case basis, depending on the amount of white deposits and the fragility of the wallpaper.

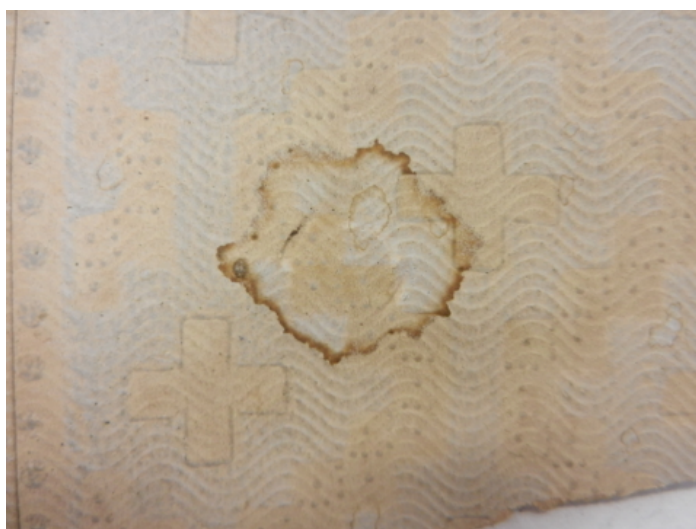
*Figure 4-13: Surface pH testing, which tends to leave a small stain on the surface of the paper, is much less destructive than extraction tests, which completely destroy the sample.*

TAPPI standards include a surface pH test (T 529), a hot extraction test (T 435), and a cold extraction test (T 509). Although surface pH testing is less destructive than extraction testing, it also only provides a value for the surface of the wallpaper, which is painted, and does not take into account the wallpaper system, including the paper itself, its adhesive materials, or other finishes or substrate material found behind the wallpaper. Extraction pH measurements, which are more destructive, provide a more accurate pH value of the entire wallpaper system. Cold extraction is preferred over hot extraction because not only does it require less working time, it is also believed to provide more accurate results.<sup>76</sup>

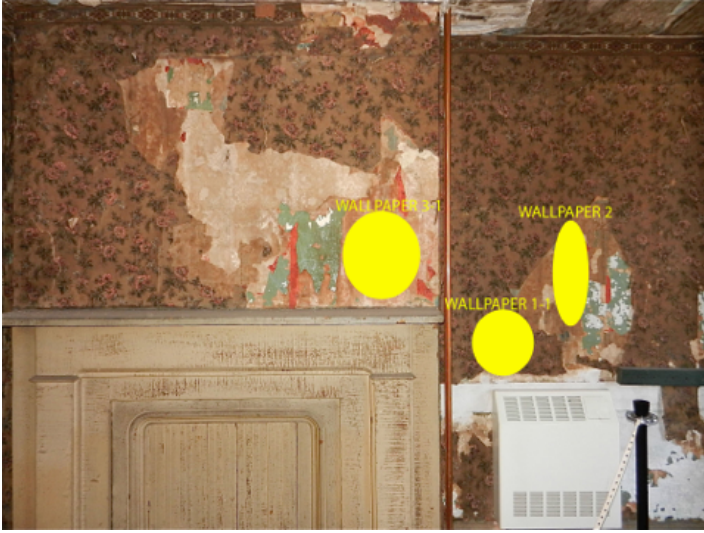
Figure 5-1: Apartment, south wall, with testing locations for wallpaper type 1-a, wallpaper type 2, and wallpaper type 3-a

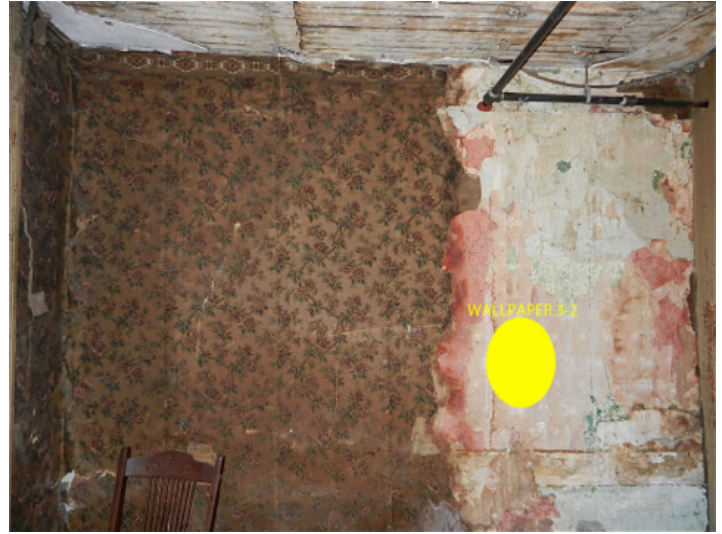
Figure 5-2: Apartment 12, north wall, with testing location for wallpaper type 3-b

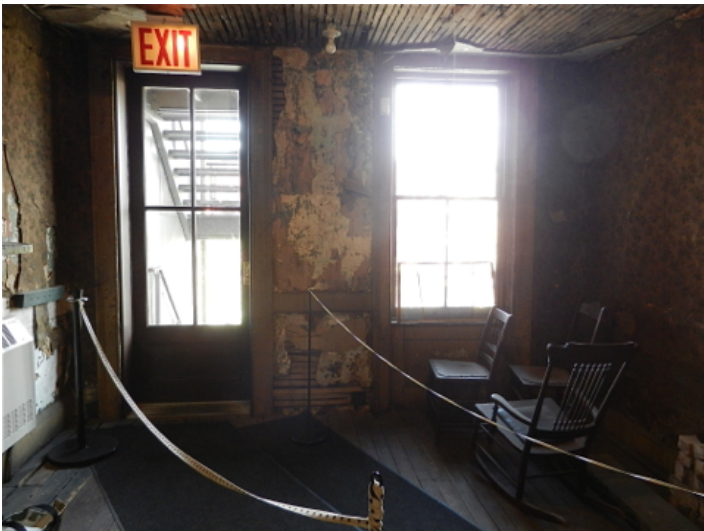
Figure 5-3: Apartment 12, west wall, with point of egress added by the museum

Wallpaper sample locations came from the parlors of two apartments at 97 Orchard Street. Apartment 12 on the fourth floor is located in the rear of the building, facing west toward what would have been the back yard and is now Allen Street. This room now serves as a point of egress for the museum, and an exterior door and staircase have been erected on the west side of the room which was not extant when people lived there. Several layers of wallpaper can be observed in this parlor, as well as the original paint finishes and plaster and lath walls.

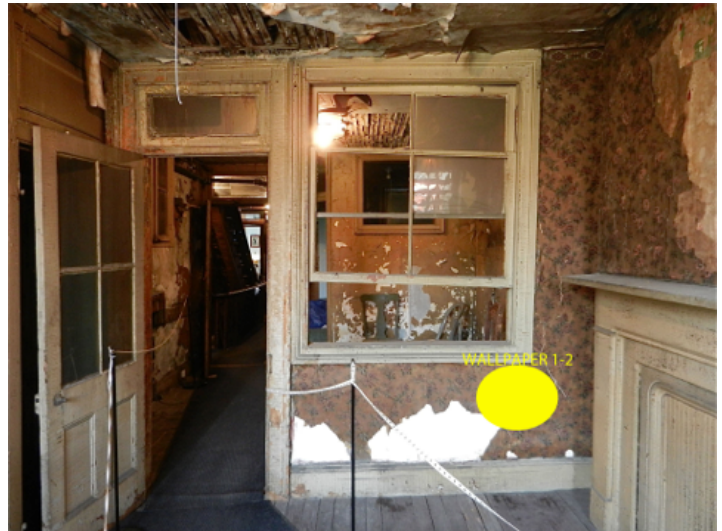
Figure 5-4: Apartment 12, east wall, with testing location for wallpaper type 1-b

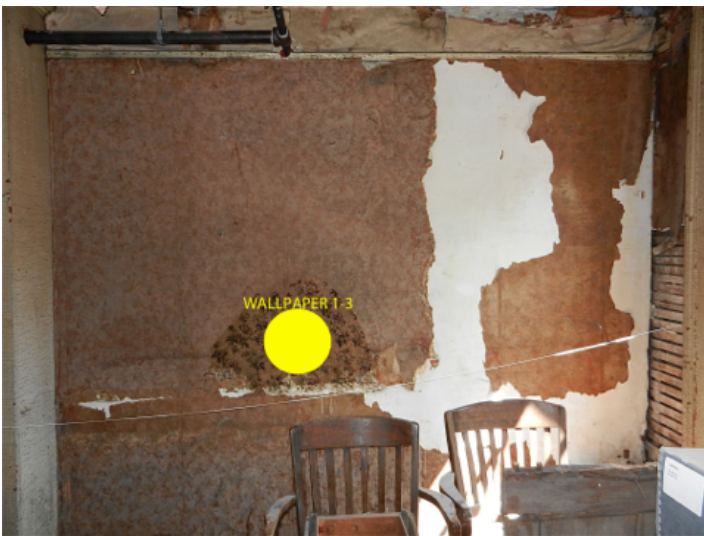
*Figure 5-5: Apartment 17, north wall, with testing location for wallpaper type 1-c*

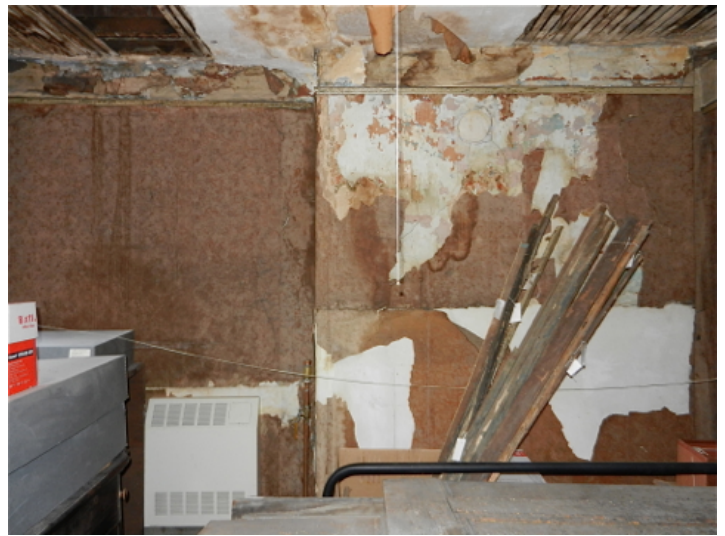
*Figure 5-6: Apartment 17, south wall*

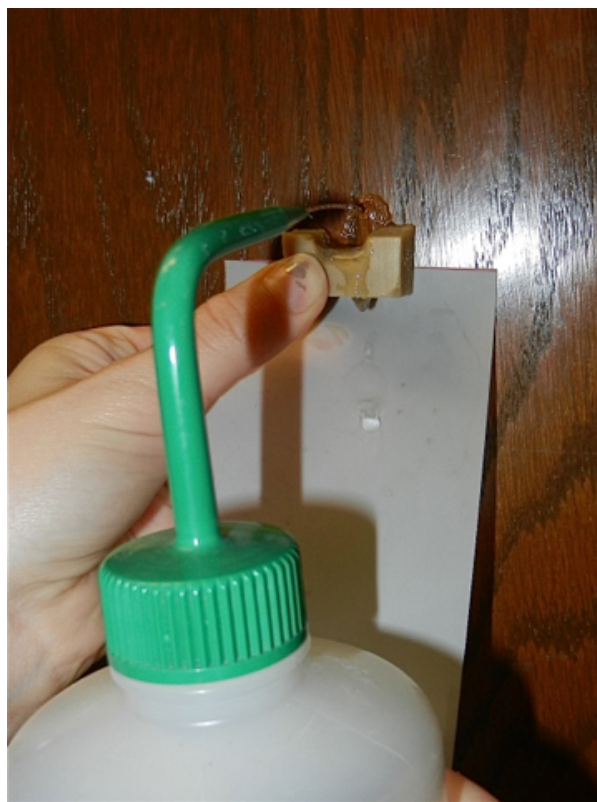
*Figure 5-8: Demonstration of how excess water was directed away from the wall during surface pH testing*

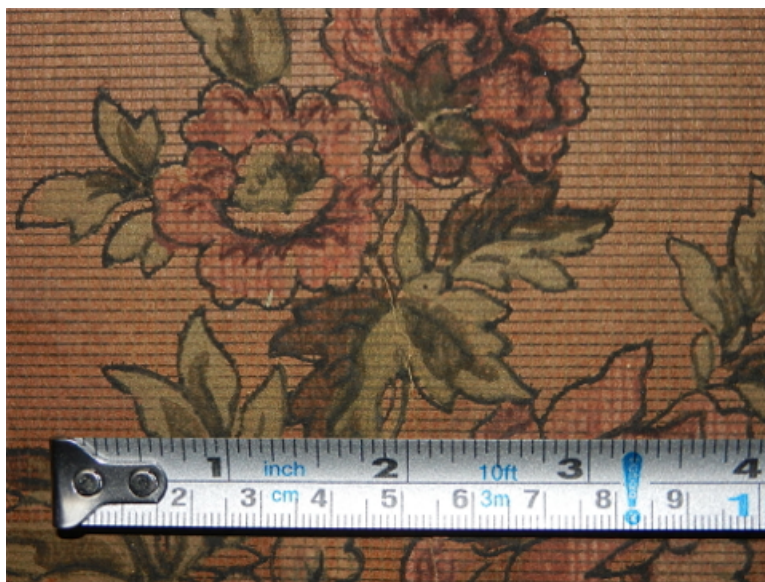
*Figure 5-10: Wallpaper sample 1-a, Apartment 12, south wall. Printed colors are not wide enough to measure with the colorimeter*

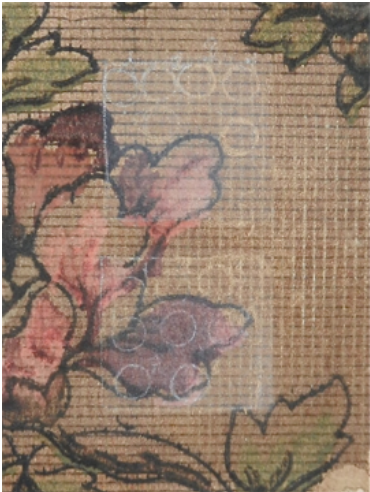
values after treating		a*	b*	ΔE
Sample #1	43.70	+8.04	+12.48	6.36
Sample #2	40.49	+10.37	+11.05	5.90

*Figure 5-12: Bookkeeper colorimeter test,  
Wallpaper type #1 - After treating*

These numbers are relatively consistent in this range and it is clear from visual observation that Bookkeeper drastically changed the appearance of wallpaper #1, no matter the color. If they were closer to zero, the differences in  $\Delta E$  values between the squares before they were cleaned and after they were treated and cleaned (1.66) would be much more significant. It was decided to use these two squares for the Bookkeeper pH testing rather than creating three new squares in another area to limit damage.

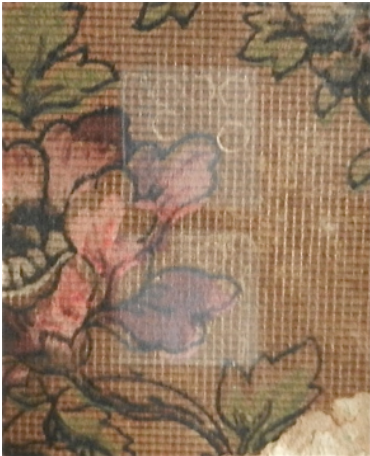
values after surface cleaning after treating			b*	ΔE
Sample #1	44.67	+8.11	+13.05	1.15
Sample #2	42.09	+9.55	+10.13	2.02

*Figure 5-13: Bookkeeper colorimeter test,  
Wallpaper type #1 - After surface cleaning  
after treating*

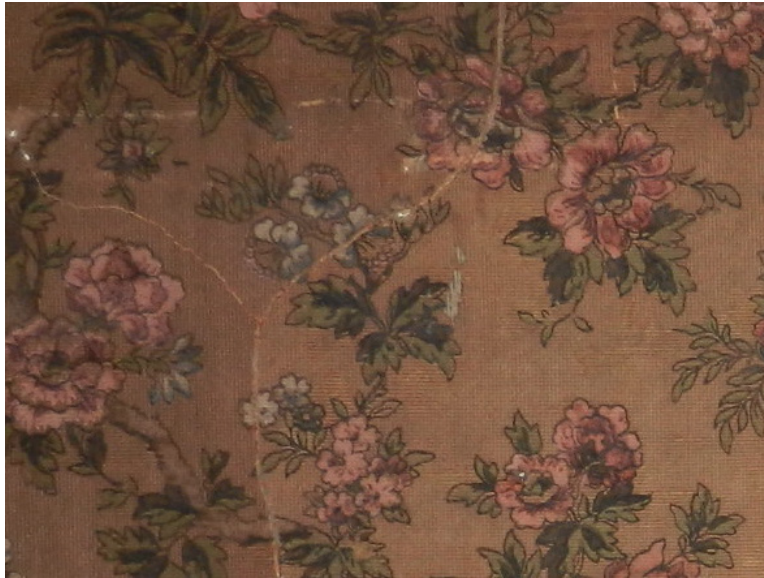
## WALLPAPER TYPE #1 - Samples 1-a, 1-b, 1-c

Wallpaper type #1 is a heavily exposed layer of wallpaper in apartment 12 and was the last to be hung in this apartment before it was condemned in 1935 it is also found in the parlor of apartment 17, but it was the second-to-last layer in that apartment. It has a waffle texture that imitates textiles and is printed in a common floral motif with green, pink, and blue colors. Close examination indicates that much of the green shading in the leaves of the design may in fact have been a metallic paint most likely with bronze, which has discolored over time.

A significant amount of this wallpaper is missing from each of the walls in apartment 12. Although it has become very brown and dark and there are many tears, it appears to be in better condition than the earlier layers beneath it because it is thicker and felt less brittle when removing samples for fiber identification. The tears on the surface also appear to be mainly the result of failure in the substrate layers and do not appear to be due to any inherent flaws in the paper itself. This paper was selected for testing because it was the easiest to access and it is found in different locations throughout the room and in the parlor of apartment 17, with different substrates.

Test result data can be found in Appendix B. Bookkeeper was effective at neutralizing this type of wallpaper but also significantly lightened the color. Sample 1-a averaged a pH of 7.57 after being treated with Bookkeeper but also became significantly lighter in color. It also became greener and bluer. Sample 1-2, which averaged a pH of 6.56 after treatment, also became significantly lighter, as well as slightly greener and bluer. The same visual results were true for sample 1-b, which reached an average pH of 6.81 after being treated with Bookkeeper. After all L\*a\*b\* measurements had been taken, the treated squares were tested for a pH measurement. Dampening the surfaces of the treated squares seemed to eradicate the white discoloration even after the water had dried.

Paper Saver demonstrated similar visual results to Bookkeeper, without its success at neutralizing the paper. Sample 1-a average a pH of 4.66 after treating with Paper Saver and it became much lighter and slightly greener and bluer. Sample 1-b averaged a pH of 4.71 after treating with Paper Saver, however, only a slight color change was measured, although it also became lighter, greener, and bluer. Sample 1-c, which also became slightly lighter, greener, and bluer, averaged a pH of 4.88 after treatment.

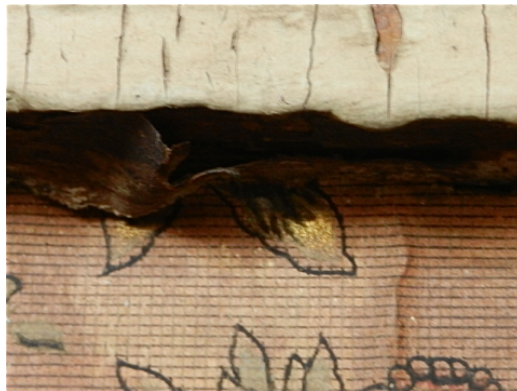
*Figure 5-16: Wallpaper sample 1-b. Gold colored leaves under the interior window sill have not yet turned green.*

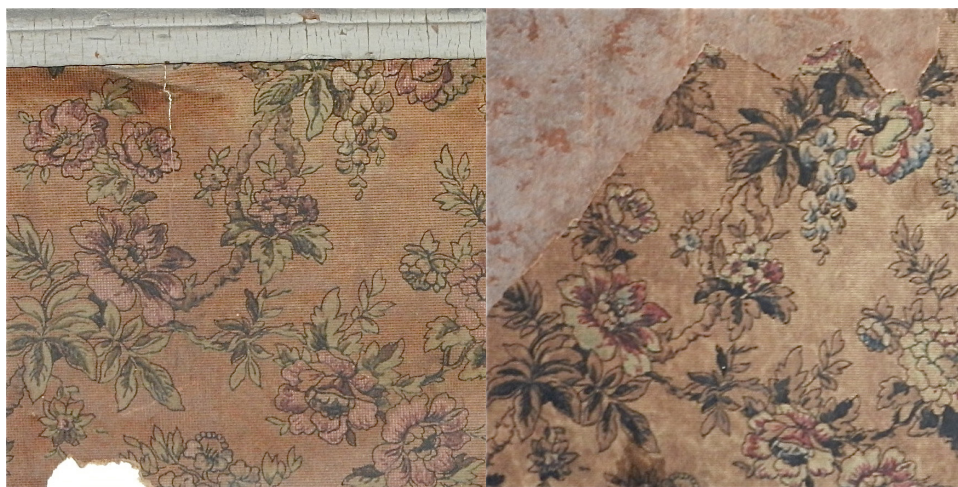
*Figure 5-17: Wallpaper samples 1-a on the left and 1-b on the right. Each has aged differently*

**Wallpaper sample 1-c** is located on the north wall of apartment 17 on the fifth floor. At first glance, it does not appear to be the same wallpaper as samples 1-a and 1-b because it has discolored differently. Sample 1-c is not as easily accessible as sample 1-a and 1-b because it is not the last layer in apartment 17. A small area above the chair rail was exposed, which was used for testing.

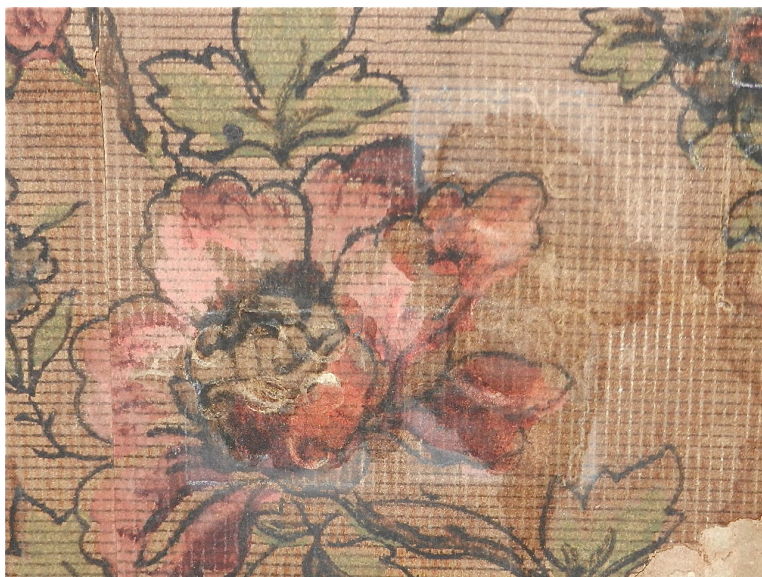
*Figure 5-18: Wallpaper sample 1-a the day after the water for pH testing had dried*

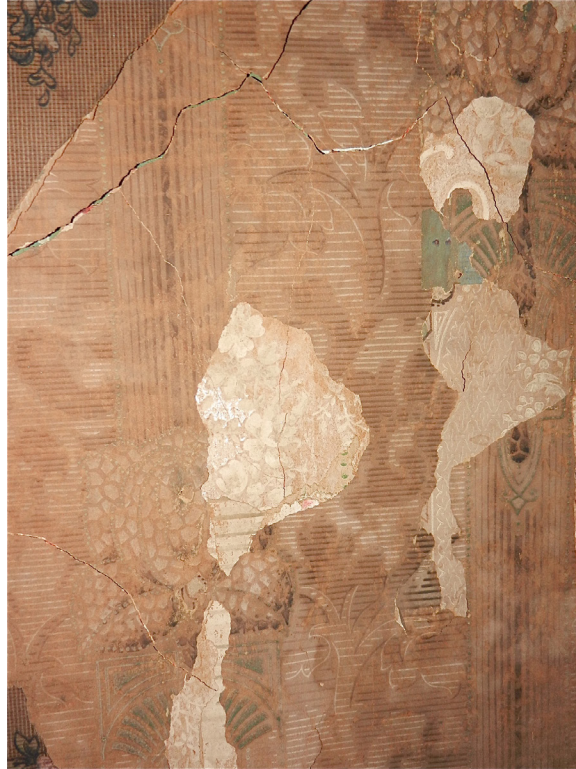
## WALLPAPER TYPE #2 - Sample 2

Identified as the eighth layer from the surface by an earlier analysis, Wallpaper type #2 is printed with an abstract floral and scroll design and alternating vertical and horizontal brown and white lines.

The fine green lines in the design, which resemble stencil patterns, may be flocked or faux flocked. This paper is thinner and more brittle than wallpaper #1 and is also more fragmented. Wallpaper type #2 was chosen for testing because it is sufficiently exposed and represents an earlier time period than the first wallpapers, possibly anywhere from sixteen to twenty-four years before wallpaper #1 according to conclusions drawn from the 1997 investigation.

Bookkeeper neutralized wallpaper type #2 just as effectively as wallpaper type #1 and discolored it to a lesser extent, although discoloration was still visually apparent. (pH 3.86 was raised to 7.43.) As with wallpaper type #1, Bookkeeper caused the wallpaper to turn significantly lighter, and a bit greener and bluer.

Wei T'o successfully neutralized sample 2, raising the average pH from 3.86 to 6.07. Slight darkening of the surface as a result of deacidification was barely noticeable in the first two squares, more so in the third. Wei T'o also caused the wallpaper to become just slightly greener and slightly bluer.

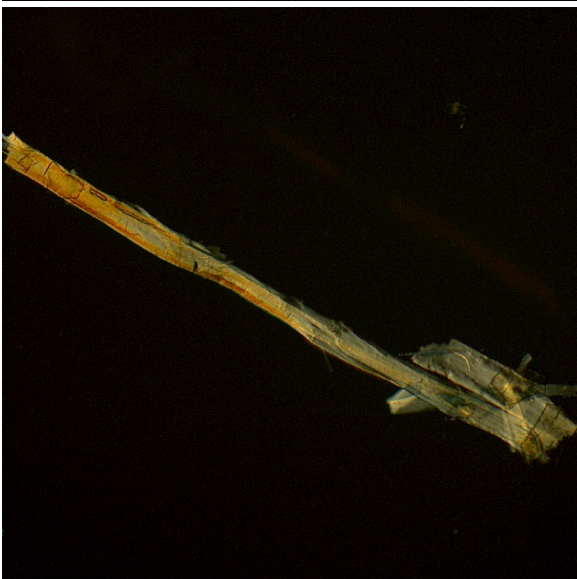
Two rows of pits, first order of interference colors, no mechanical wood properties such as medullary rays.

*Coniferous chemical wood*

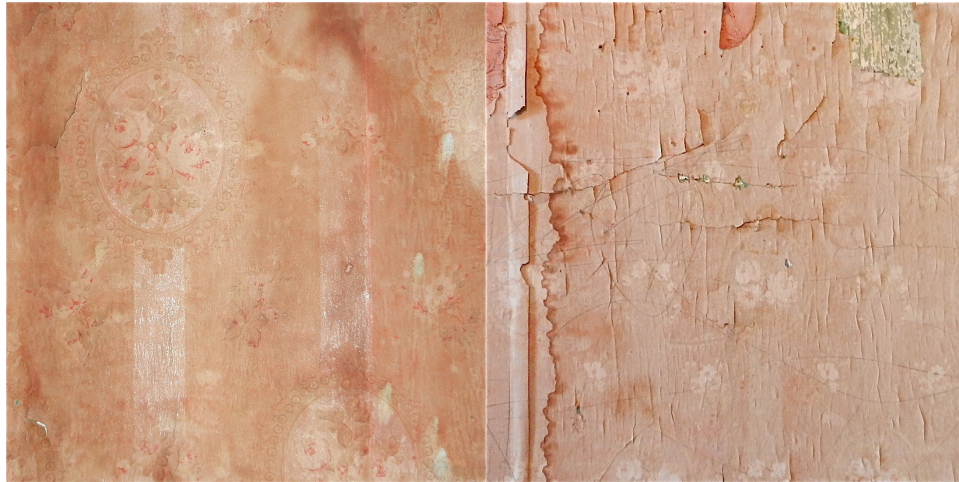
Figure 5-19: Wallpaper samples 3-a on the left and 3-b on the right. Each has aged differently

It is several decades older than wallpaper types #1 and #2 and appears to be in the worst condition of the three. It is stained, presumably from water damage in some areas, and bleached in others. The edges are darkened and tearing and the printed design is faded and difficult to read, although a silver glimmer in the vertical stripes is still clearly discernible in raking light. Sample 3-a is located on the south wall of the parlor in apartment 12, while sample 3-b is located on the north wall in the same room. Both samples are adhered directly to a green oil-based paint that is failing and flaking from the surface. Although sample 3-a and 3-b are the same material, they appear different and were found in different conditions because of the differences in their exposure to direct sunlight.

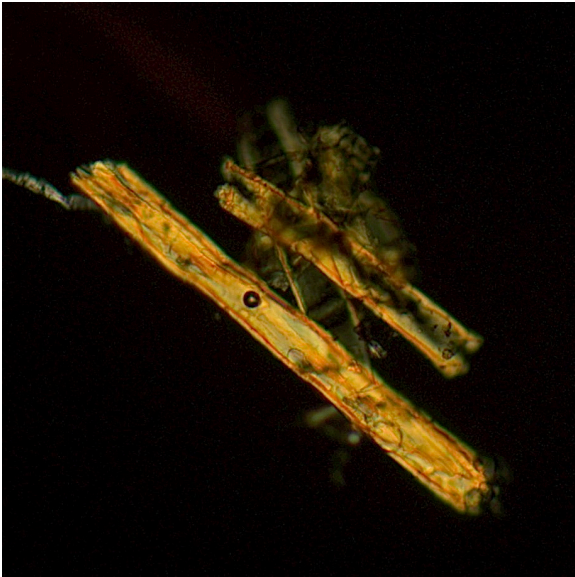
Translucent bundles. Apparent parallel extinction

*Bast (Flax or Jute)*

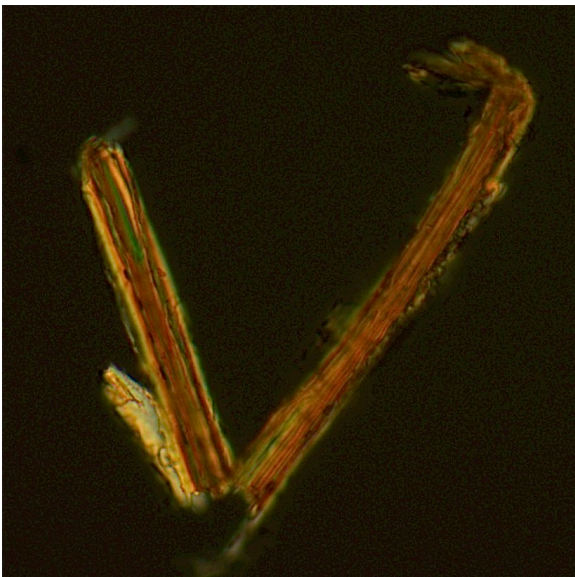
A row of short brick-shaped cells on a diagonal slant. Interference colors are first order grey with good extinction.

*Coniferous chemical wood*

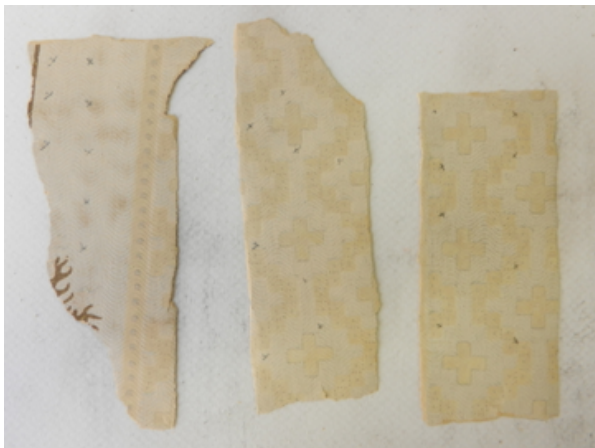
**After Surface Cleaning**

L*	a*	b*
Sample #1	74.89	+5.39	+15.23
Sample #2	73.65	+5.34	+15.33
Sample #3	74.16	+4.93	+14.70
Avg.	74.23	+5.22	+15.09
Variance	1.52 (lighter)	-0.02 (greener)	-0.07 (bluer)
$\Delta E = 1.52$

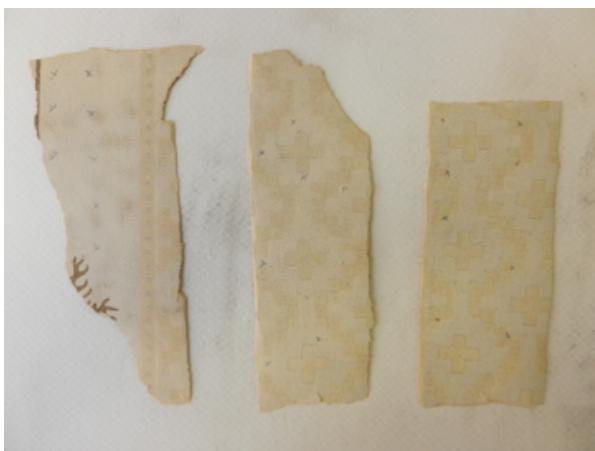
**After Treating**

L*	a*	b*
Sample #1	75.85	+4.44	+11.71
Sample #2	74.71	+4.52	+12.33
Sample #3	74.94	+4.38	+12.67
Avg.	75.17	+4.45	+12.24
Variance	0.94 (lighter)	-0.77 (greener)	-2.85 (bluer)
$\Delta E = 3.10$

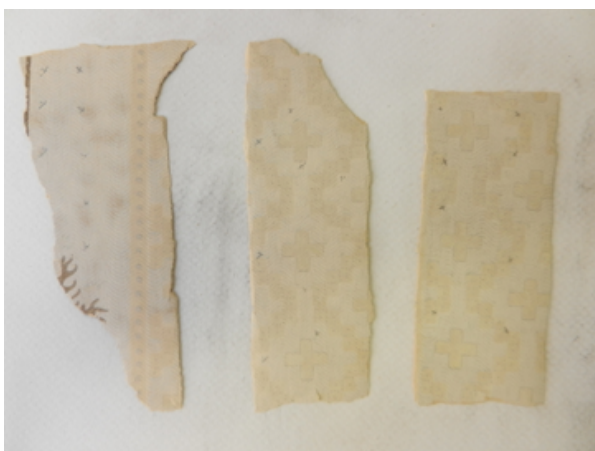
**After Surface Cleaning After Treating**

L*	a*	b*
Sample #1	75.46	+4.74	+12.69
Sample #2	74.31	+4.76	+13.14
Sample #3	74.65	+4.50	+13.01
Avg.	74.81	+4.67	+12.95
Variance	-0.36 (darker)	0.22 (redder)	0.71 (yellower)
$\Delta E = 0.83$

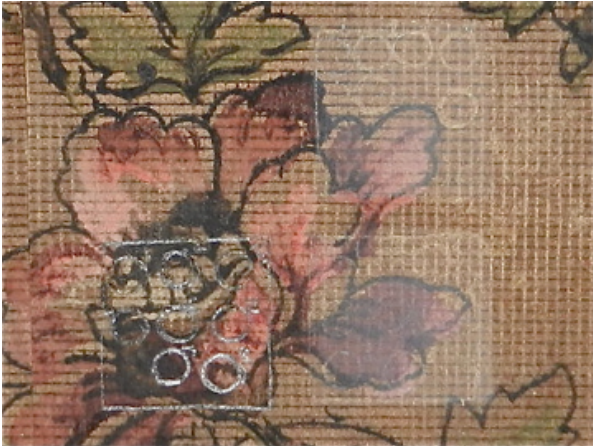
**After Surface Cleaning**

<b>L*</b>	<b>a*</b>	<b>b*</b>
<b>Sample #1</b>	40.20	+10.10	+17.32
<b>Sample #2</b>	36.04	+12.33	+14.38
<b>Sample #3</b>	35.94	+7.77	+11.27
<b>Avg.</b>	37.39	+10.07	+14.32
<b>Variance</b>	2.04	1.17	1.53

**$\Delta E = 2.81$**

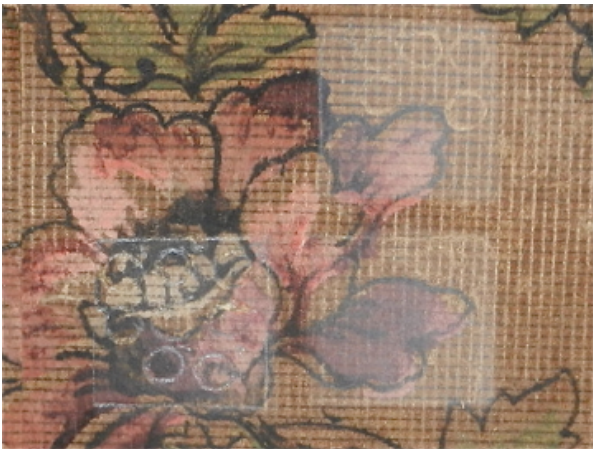
**After Treating**

<b>L*</b>	<b>a*</b>	<b>b*</b>
<b>Sample #1</b>	43.70	+8.04	+12.48
<b>Sample #2</b>	36.04	+10.37	+11.05
<b>Sample #3</b>	39.40	+7.05	+9.70
<b>Avg.</b>	39.71	+8.49	+11.08
<b>Variance</b>	2.32	-1.58	-3.24

**$\Delta E = 4.29$**

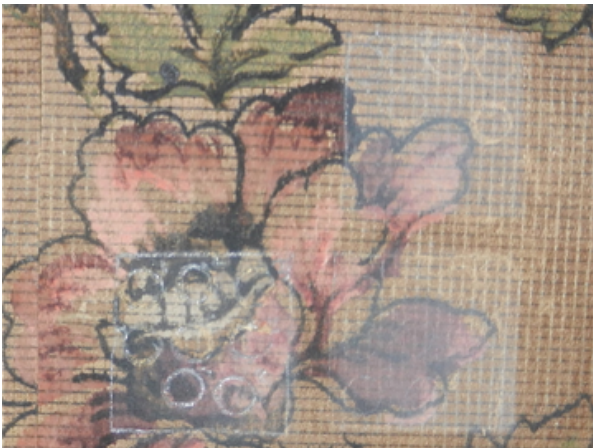
**After Surface Cleaning After Treating**

<b>L*</b>	<b>a*</b>	<b>b*</b>
<b>Sample #1</b>	44.67	+8.11	+13.05
<b>Sample #2</b>	42.09	+9.55	+10.13
<b>Sample #3</b>	39.69	+7.30	+10.18
<b>Avg.</b>	42.15	+8.32	+11.12
<b>Variance</b>	2.44	-0.17	0.04

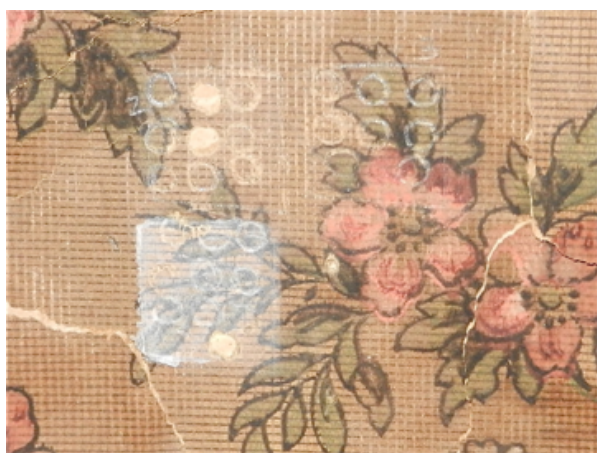
After Treating

L*	a*	b*
Sample #1	48.52	+2.95	+5.00
Sample #2	46.26	+7.55	+15.31
Sample #3	39.06	+6.89	+13.32
Avg.	44.61	+5.80	+11.21
Variance	5.02 (lighter)	-1.33 (greener)	-2.57 (bluer)
$\Delta E = 5.80$

\* Circle #2 in box #2 was lost when sprayed with Paper Saver. Circle number eight was therefore measured twice because both circles 2 and 8 were located on the ground color.

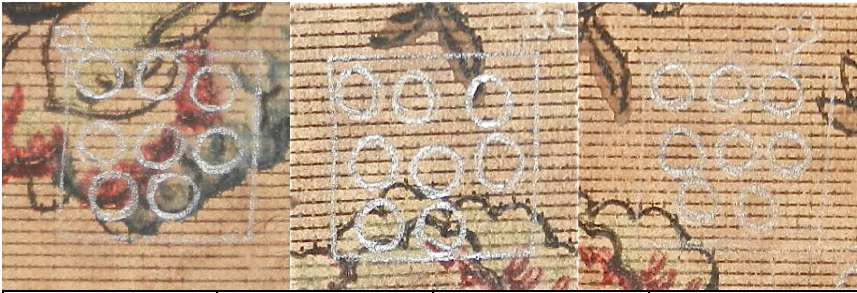
## WALLPAPER 1-c: BOOKKEEPER

<b>L*</b>	<b>a*</b>	<b>b*</b>
<b>Sample #1</b>	39.43	+8.50	+13.61
<b>Sample #2</b>	42.80	+9.29	+17.54
<b>Sample #3</b>	46.07	+10.32	+19.54
<b>Avg.</b>	42.77	+9.37	+16.90
<b>Variance</b>	0.33	-0.92	-1.88
<b><math>\Delta E = 2.11</math></b>

**After Surface Cleaning**

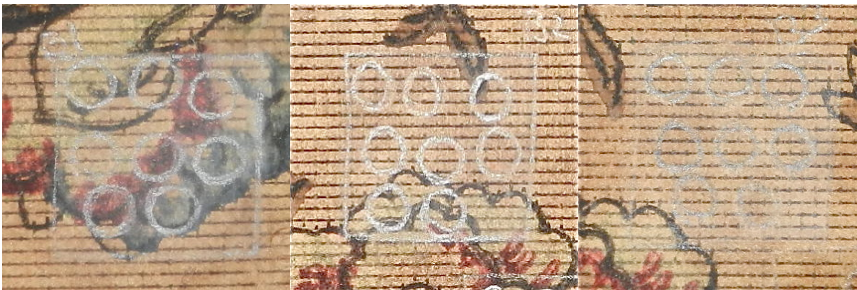
<b>L*</b>	<b>a*</b>	<b>b*</b>
<b>Sample #1</b>	42.70	+7.06	+10.54
<b>Sample #2</b>	45.33	+8.48	+15.66
<b>Sample #3</b>	49.01	+9.41	+17.86
<b>Avg.</b>	45.68	+8.32	+14.69
<b>Variance</b>	2.91	-1.05	-2.21
<b><math>\Delta E = 3.80</math></b>

**After Treating**

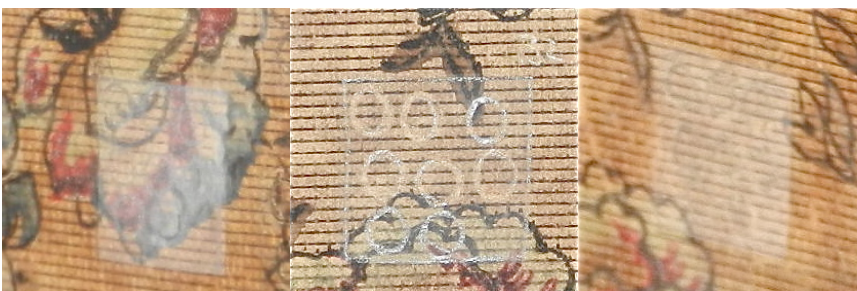
<b>L*</b>	<b>a*</b>	<b>b*</b>
<b>Sample #1</b>	42.58	+6.78	+10.52
<b>Sample #2</b>	45.47	+8.32	+15.57
<b>Sample #3</b>	48.92	+9.27	+17.92
<b>Avg.</b>	45.66	+8.12	+14.67
<b>Variance</b>	-0.02	-0.20	-0.02
<b><math>\Delta E = 0.20</math></b>

**After Surface Cleaning After Treating**

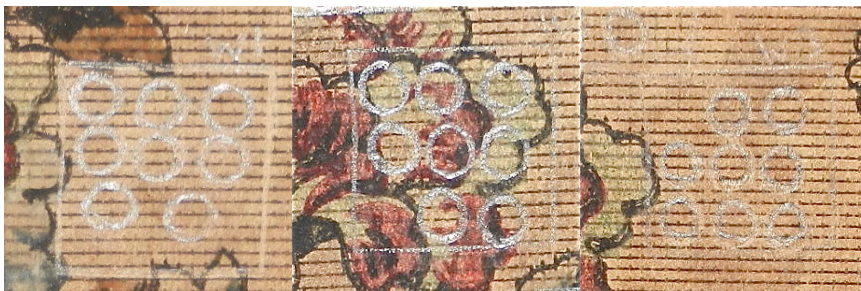
## WALLPAPER 1-c: WEI T'O

<b>L*</b>	<b>a*</b>	<b>b*</b>
<b>Sample #1</b>	45.44	+10.65	+20.01
<b>Sample #2</b>	42.76	+9.13	+16.60
<b>Sample #3</b>	45.76	+10.32	+18.91
<b>Avg.</b>	44.65	+10.03	+18.51
<b>Variance</b>	0.36	-0.76	-1.48
<b><math>\Delta E = 1.70</math></b>

**After Surface Cleaning**

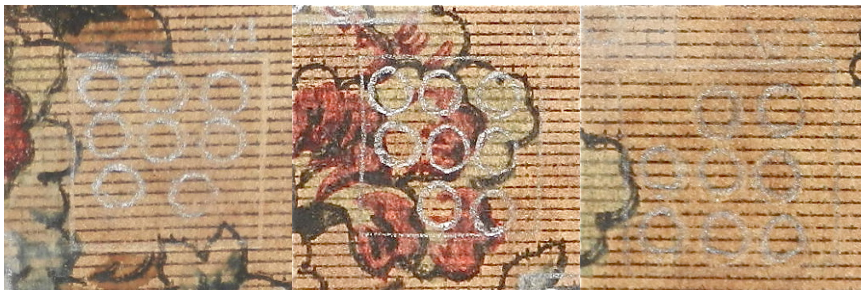
<b>L*</b>	<b>a*</b>	<b>b*</b>
<b>Sample #1</b>	45.23	+9.98	+18.81
<b>Sample #2</b>	42.02	+9.42	+17.21
<b>Sample #3</b>	43.85	+10.53	+19.74
<b>Avg.</b>	43.70	+9.98	+18.59
<b>Variance</b>	-0.95	-0.05	0.08
<b><math>\Delta E = 0.94</math></b>

**After Treating**

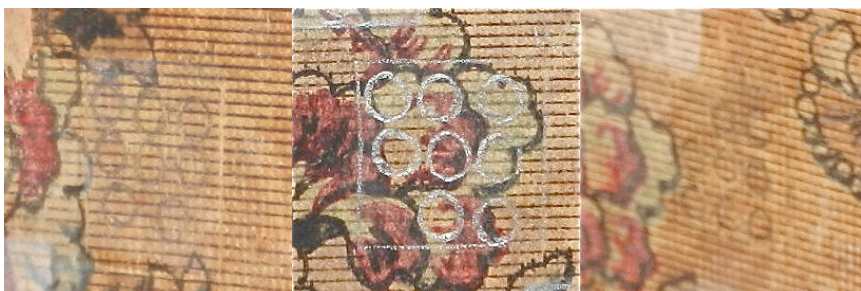
<b>L*</b>	<b>a*</b>	<b>b*</b>
<b>Sample #1</b>	45.67	+9.93	+18.94
<b>Sample #2</b>	42.89	+9.02	+16.37
<b>Sample #3</b>	44.39	+10.00	+18.67
<b>Avg.</b>	44.32	+9.65	+17.99
<b>Variance</b>	0.62	-0.33	-0.60
<b><math>\Delta E = 0.92</math></b>

**After Surface Cleaning After Treating**

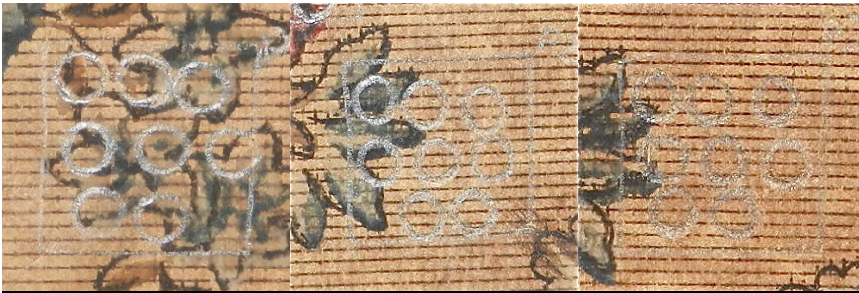
## WALLPAPER 1-c: PAPER SAVER

<b>L*</b>	<b>a*</b>	<b>b*</b>
<b>Sample #1</b>	39.62	+7.94	+14.91
<b>Sample #2</b>	43.52	+9.92	+18.03
<b>Sample #3</b>	44.49	+10.40	+18.43
<b>Avg.</b>	42.54	+9.42	+17.12
<b>Variance</b>	0.61	-0.66	-1.20
<b><math>\Delta E = 1.50</math></b>

**After Surface Cleaning**

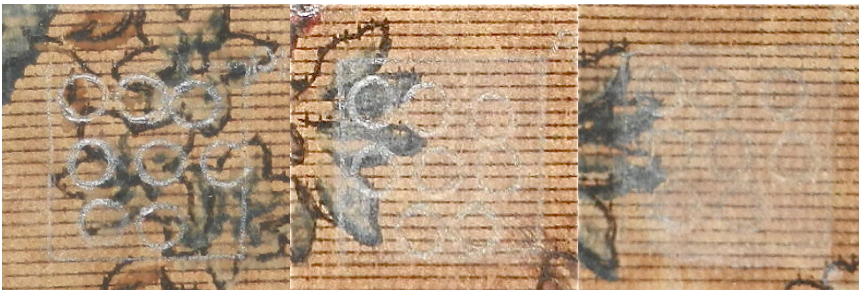
<b>L*</b>	<b>a*</b>	<b>b*</b>
<b>Sample #1</b>	39.27	+7.77	+14.57
<b>Sample #2</b>	46.52	+8.36	+14.80
<b>Sample #3</b>	48.04	+8.88	+15.43
<b>Avg.</b>	44.61	+8.34	+14.93
<b>Variance</b>	2.07	-1.08	-2.19
<b><math>\Delta E = 3.20</math></b>

**After Treating**

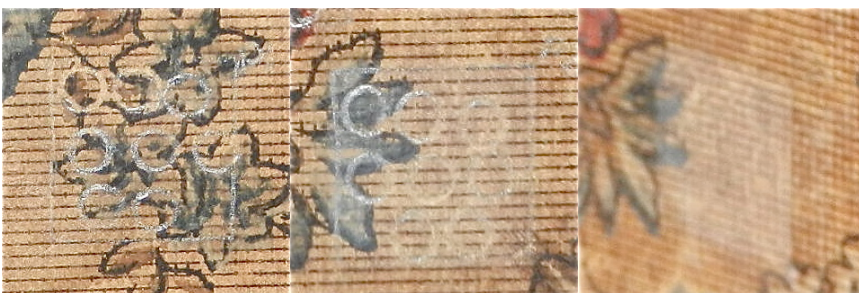
<b>L*</b>	<b>a*</b>	<b>b*</b>
<b>Sample #1</b>	39.82	+7.77	+14.65
<b>Sample #2</b>	46.44	+8.85	+16.02
<b>Sample #3</b>	47.05	+9.31	+16.90
<b>Avg.</b>	44.44	+8.64	+15.86
<b>Variance</b>	-0.17	0.30	0.93
<b><math>\Delta E = 0.99</math></b>

**After Surface Cleaning After Treating**

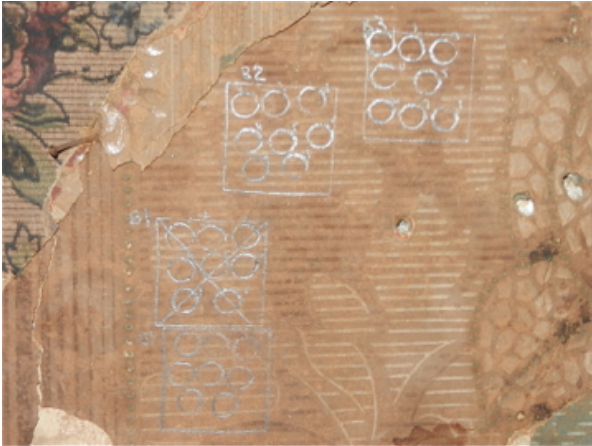
## WALLPAPER 2: BOOKKEEPER

**After Surface Cleaning**

<b>L*</b>	<b>a*</b>	<b>b*</b>
<b>Sample #1</b>	46.26	+12.45	+21.40
<b>Sample #2</b>	47.05	+12.01	+20.84
<b>Sample #3</b>	44.62	+11.58	+19.57
<b>Avg.</b>	45.98	+12.01	+20.60
<b>Variance</b>	-0.43	-0.01	-0.16
<b><math>\Delta E = 0.46</math></b>

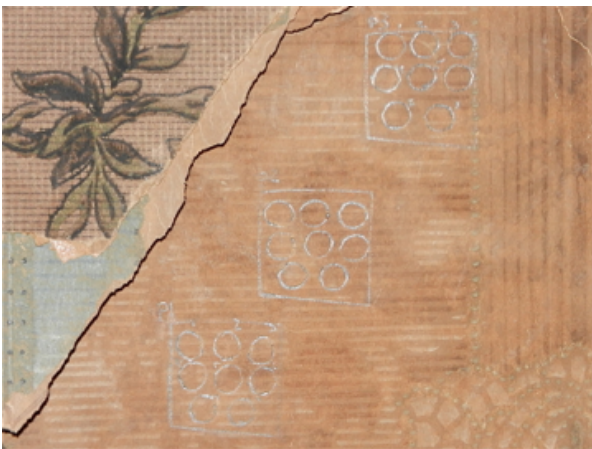
**After Treating**

<b>L*</b>	<b>a*</b>	<b>b*</b>
<b>Sample #1</b>	49.87	+10.35	+16.60
<b>Sample #2</b>	48.69	+11.13	+18.67
<b>Sample #3</b>	47.04	+10.19	+16.48
<b>Avg.</b>	48.53	+10.56	+17.25
<b>Variance</b>	2.55	-1.45	-3.35
<b><math>\Delta E = 4.45</math></b>

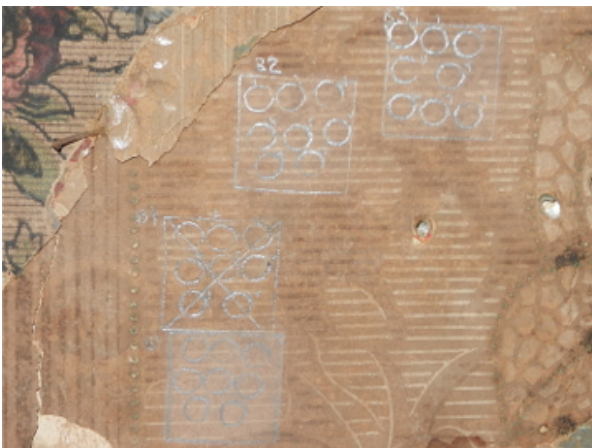
**After Surface Cleaning After Treating**

<b>L*</b>	<b>a*</b>	<b>b*</b>
<b>Sample #1</b>	49.45	+9.91	+15.98
<b>Sample #2</b>	47.78	+10.66	+17.83
<b>Sample #3</b>	46.82	+10.14	+16.50
<b>Avg.</b>	48.02	+10.24	+16.77
<b>Variance</b>	-0.51	-0.32	-0.48
<b><math>\Delta E = 0.77</math></b>

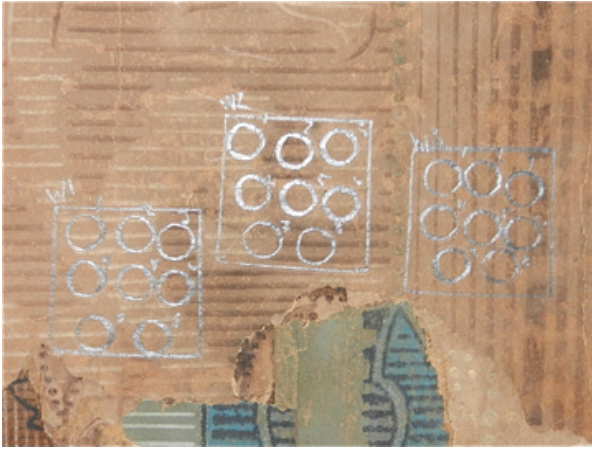
## WALLPAPER 2: WEI T'O

**After Surface Cleaning**

<b>L*</b>	<b>a*</b>	<b>b*</b>
<b>Sample #1</b>	45.30	+11.18	+19.71
<b>Sample #2</b>	42.84	+9.57	+16.91
<b>Sample #3</b>	42.74	+10.69	+17.94
<b>Avg.</b>	43.63	+10.48	+18.19
<b>Variance</b>	0.70	-0.32	-0.66
<b><math>\Delta E = 1.01</math></b>

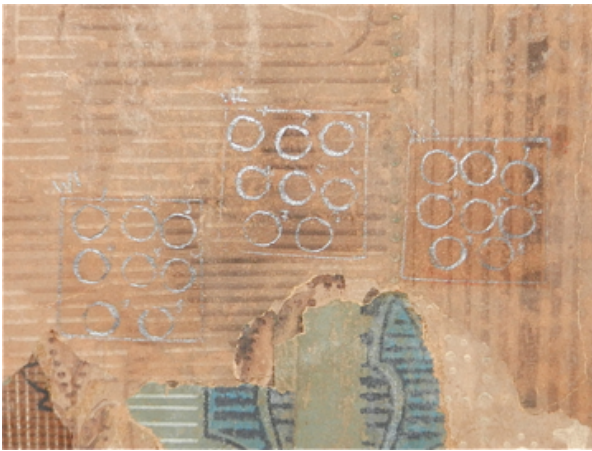
**After Treating**

<b>L*</b>	<b>a*</b>	<b>b*</b>
<b>Sample #1</b>	42.52	+11.94	+20.42
<b>Sample #2</b>	39.97	+10.12	+17.37
<b>Sample #3</b>	39.43	+11.74	+19.14
<b>Avg.</b>	40.64	+11.27	+18.98
<b>Variance</b>	-2.99	0.79	0.79
<b><math>\Delta E = 3.19</math></b>

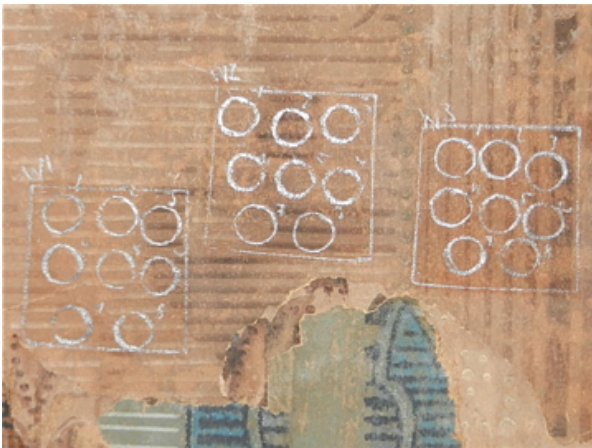
**After Surface Cleaning After Treating**

<b>L*</b>	<b>a*</b>	<b>b*</b>
<b>Sample #1</b>	43.41	+11.42	+19.68
<b>Sample #2</b>	41.14	+9.43	+16.28
<b>Sample #3</b>	40.61	+10.72	+17.42
<b>Avg.</b>	41.72	+10.52	+17.79
<b>Variance</b>	1.08	-0.75	-1.19
<b><math>\Delta E = 1.77</math></b>

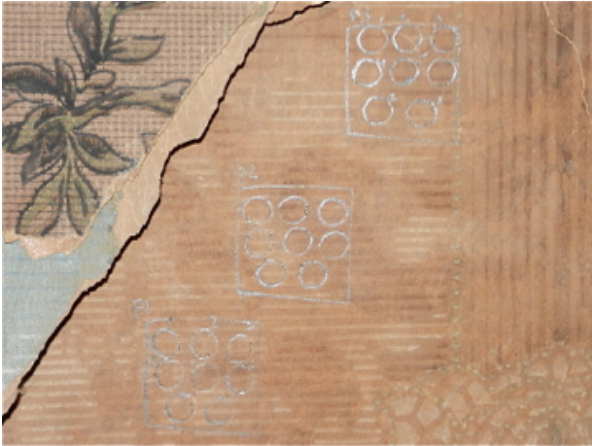
## WALLPAPER 2: PAPER SAVER

**After Surface Cleaning**

<b>L*</b>	<b>a*</b>	<b>b*</b>
<b>Sample #1</b>	46.25	+13.44	+22.60
<b>Sample #2</b>	45.65	+13.29	+22.27
<b>Sample #3</b>	45.25	+13.26	+22.23
<b>Avg.</b>	45.72	+13.33	+22.37
<b>Variance</b>	0.14	-0.02	-0.25
<b><math>\Delta E = 0.29</math></b>

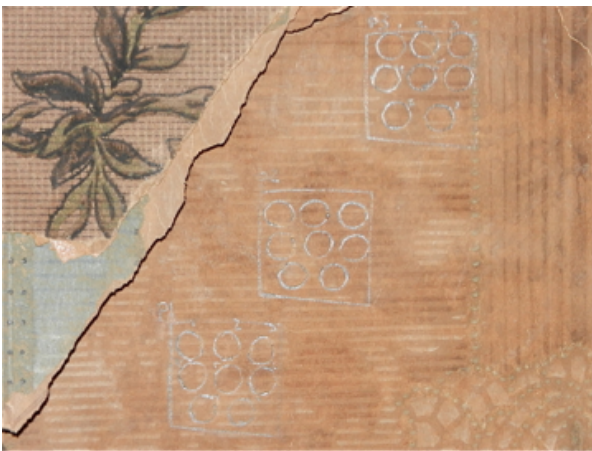
**After Treating**

<b>L*</b>	<b>a*</b>	<b>b*</b>
<b>Sample #1</b>	46.68	+13.71	+22.13
<b>Sample #2</b>	45.93	+13.41	+22.55
<b>Sample #3</b>	45.59	+13.27	+22.34
<b>Avg.</b>	46.07	+13.46	+22.34
<b>Variance</b>	0.35	0.13	-0.03
<b><math>\Delta E = 0.37</math></b>

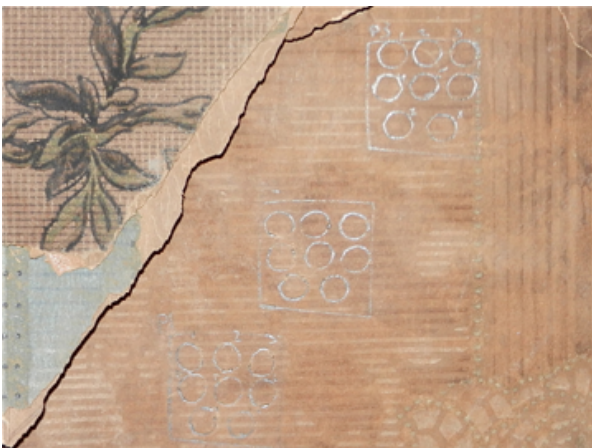
**After Surface Cleaning After Treating**

<b>L*</b>	<b>a*</b>	<b>b*</b>
<b>Sample #1</b>	46.53	+13.37	+22.43
<b>Sample #2</b>	45.79	+13.19	+22.01
<b>Sample #3</b>	45.35	+13.00	+21.74
<b>Avg.</b>	45.89	+13.19	+22.06
<b>Variance</b>	-0.18	-0.37	-0.28
<b><math>\Delta E = 0.50</math></b>

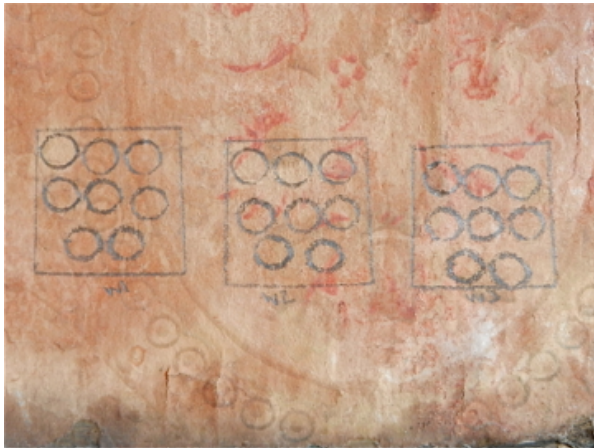
# WALLPAPER 3-a: WEI T'O

After Surface Cleaning

L*	a*	b*
Sample #1	52.14	+15.30	+25.69
Sample #2	54.19	+14.98	+24.10
Sample #3	53.68	+14.16	+21.88
Avg.	53.34	+14.81	+23.89
Variance	-0.40	-0.63	-1.21
$\Delta E = 1.42$

\* Wei T'o testing squares were placed too close to the mantle, making the lower circles somewhat inaccessible with the colorimeter.  $L^*a^*b^*$  measurements were taken of the bottom circles by tilting the colorimeter and aiming the aperture at the center of the circles rather than holding it flush against the surface. This may have significantly skewed  $L^*a^*b^*$  data, therefore visual monitoring was more heavily relied upon.

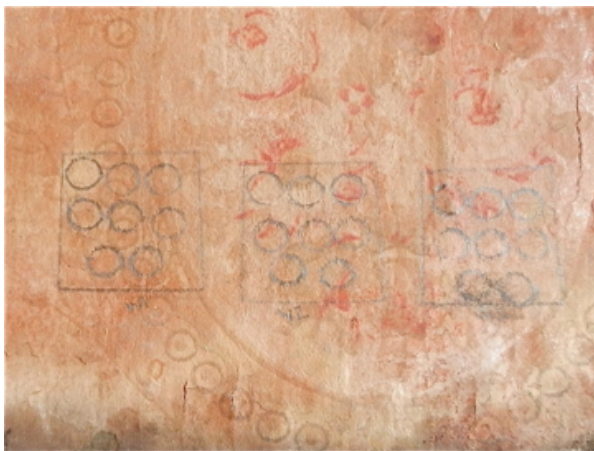
After Treating

L*	a*	b*
Sample #1	51.02	+15.34	+25.81
Sample #2	53.50	+15.09	+24.13
Sample #3	52.02	+13.99	+21.55
Avg.	52.18	+15.18	+23.83
Variance	-1.16	0.37	-0.06
$\Delta E = 1.22$

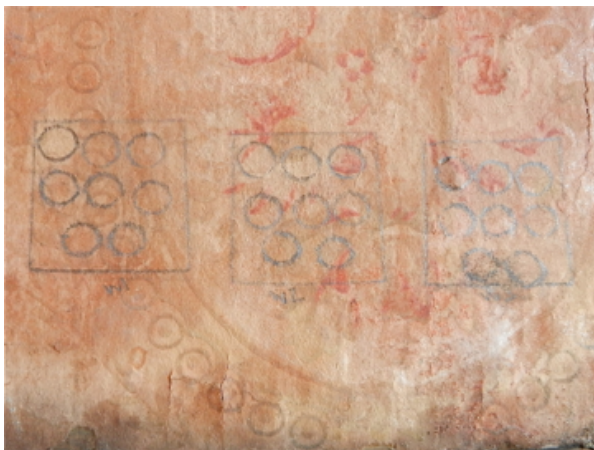
After Surface Cleaning After Treating

L*	a*	b*
Sample #1	51.89	+15.12	+25.32
Sample #2	53.83	+14.85	+23.93
Sample #3	53.55	+13.76	+21.53
Avg.	53.09	+14.58	+23.59
Variance	0.91	-0.60	-0.24
$\Delta E = 1.12$
